A Report on Field Exposure Tests of Five Types of Reflective Sheeting Material

February 1958

State of California
Department of Public Works
Division Highways
Materials and Research Department

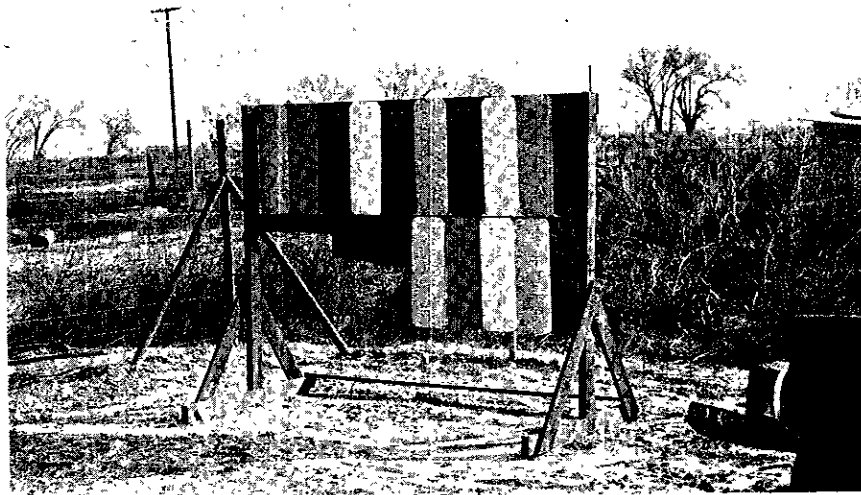
Figure 1 - Exposure Rack, District VI,
Valley Area

The maintenance yard test site is located in the southern corner of the Lemoore Maintenance Yard in the town of Lemoore, 34 miles south of Fresno on State Sign Route 41. The test rack faces north and south. This installation (see Figure 1) was completed on June 13, 1955.

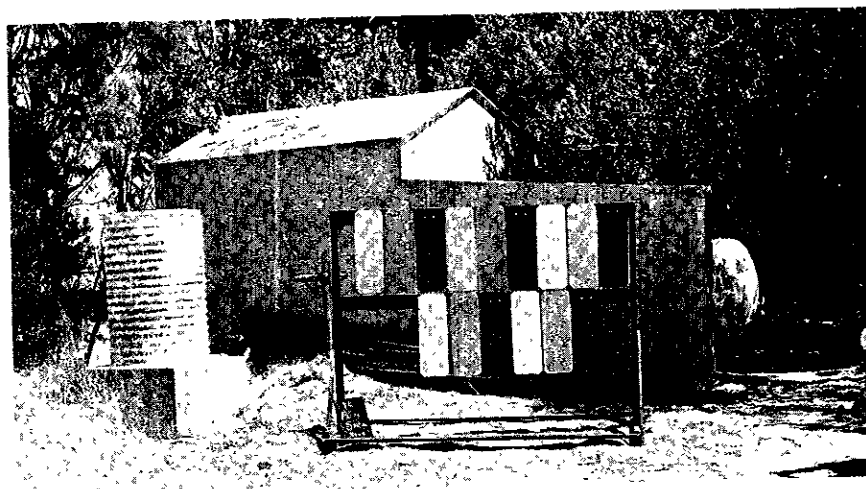
Figure 2 - Exposure Rack, District VIII,
Desert Area

The maintenance yard test site is located in the northeast corner of the Palm Springs Maintenance Yard, five miles north of the city of Palm Springs on State Sign Route 111 (see Figure 2). The exposure rack, which faces north and south, was installed on June 16, 1955.

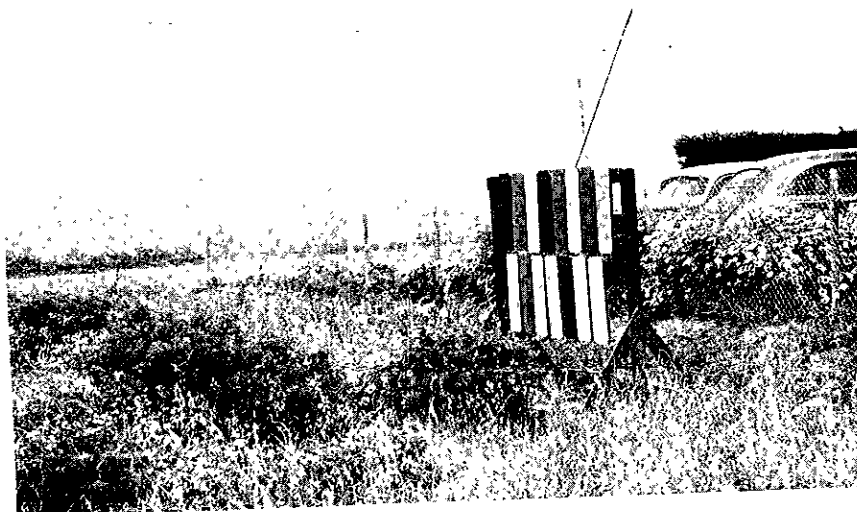
Figure 3 - Exposure Rack, District V,
Coastal Area

The maintenance yard test site is situated in District V in the Cambria Maintenance Yard, one mile north of the city of Cambria on State Sign Route 1. The exposure rack (see Figure 3), 100 feet east of the highway and 300 feet from the ocean edge, was installed on June 21, 1955.

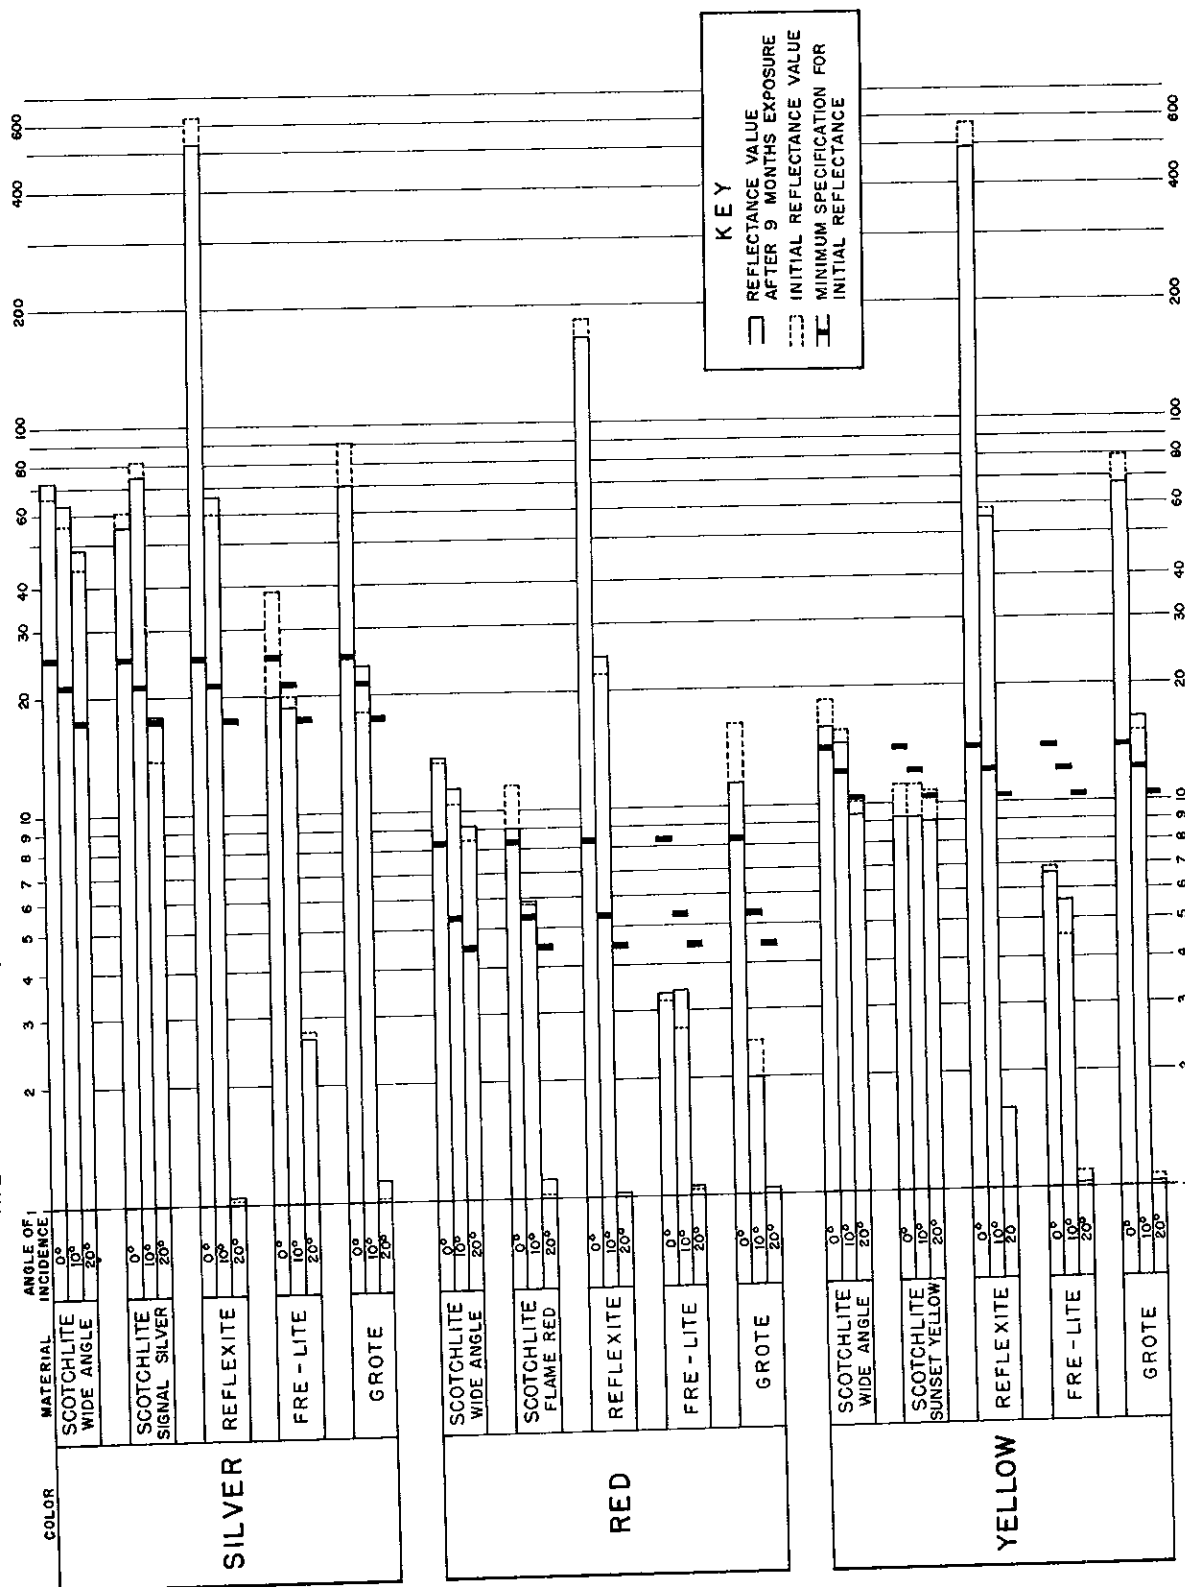
REFLECTANCE VALUES AT 9 MONTHS CANDLE POWER PER FOOT CANDLE PER SQUARE FOOT

Reflectance measurements of the panels are tabulated in Figure 13 and shown graphically in Figures 14 and 15. The reflectance readings are reported in candle power per foot candle per square foot. No correction for color change has been made.

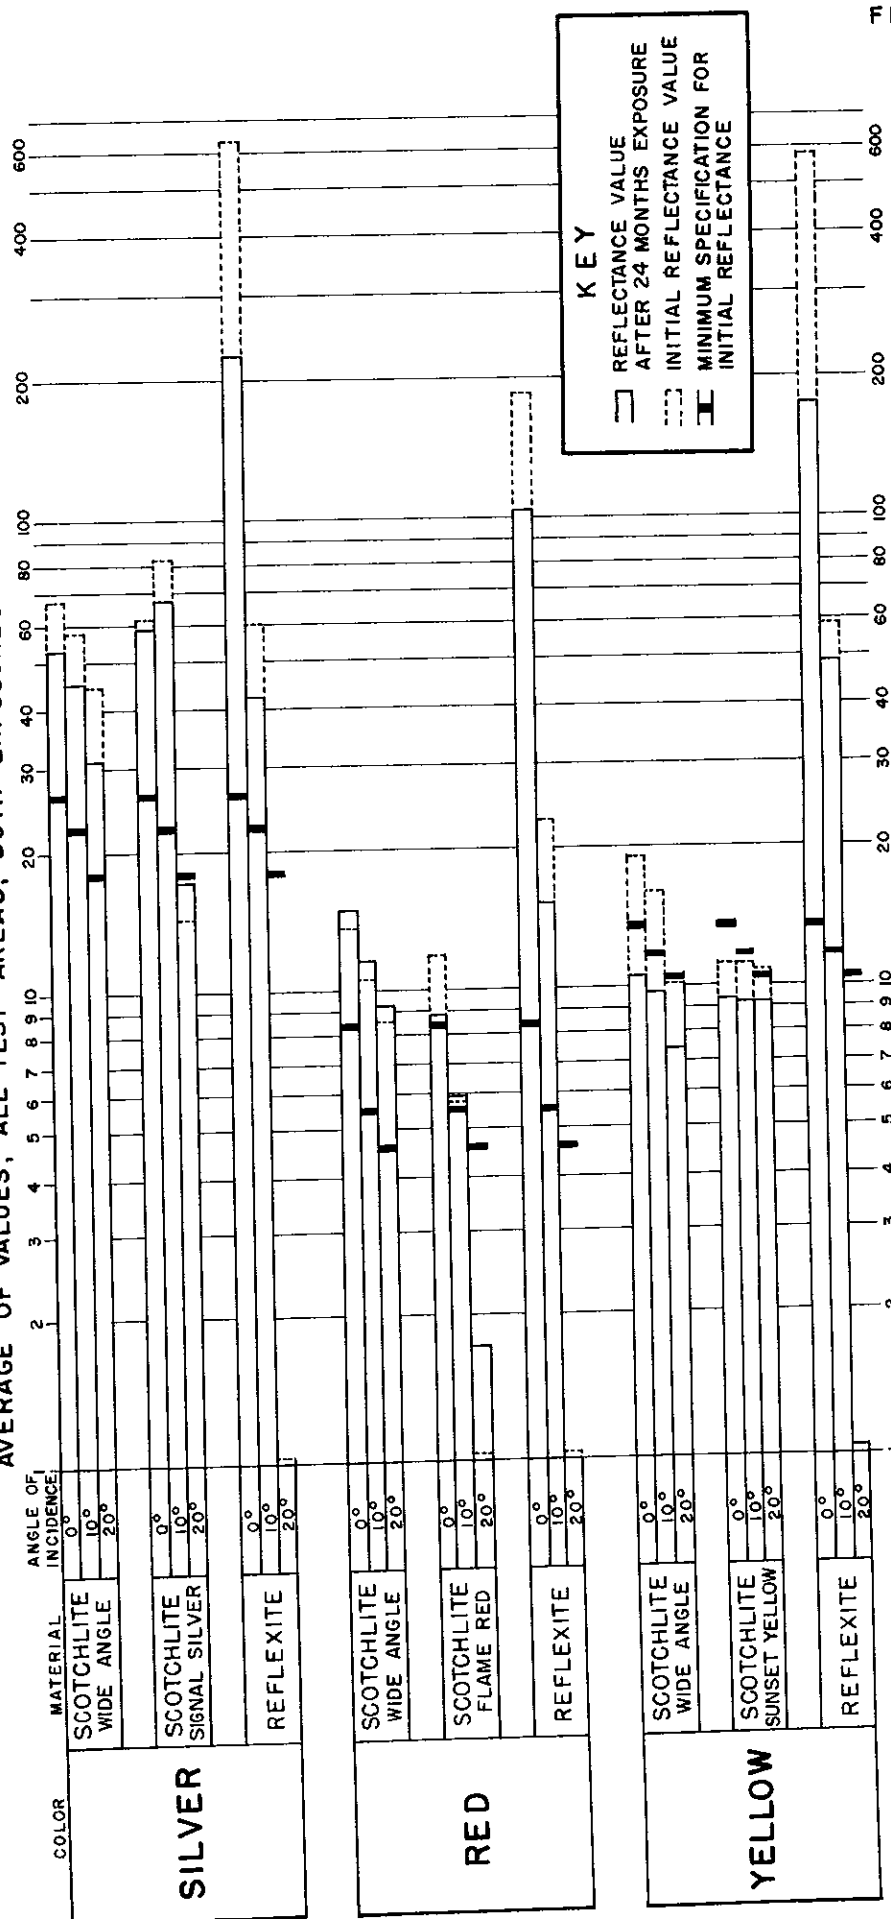
REFLECTANCE VALUES AT 24 MONTHS CANDLE POWER PER FOOT CANDLE PER SQUARE FOOT

Since Type F and Type G panels had failed physically under exposure, the reflectance values for these types of sheeting are not included in Figures 13 and 15.

Type SS signal silver panels show a loss in reflectance in all locations except the valley and coastal maintenance yard test sites. The wide angle characteristics of Type SS panels are retained after prolonged exposure, as shown in Figures 13 and 15.
